CASE STUDY 3 – (Leak Test of V type Cylinder Block)

Machine Supplied : Semi Auto Dry Leak Test machine for V- type Engine Block.

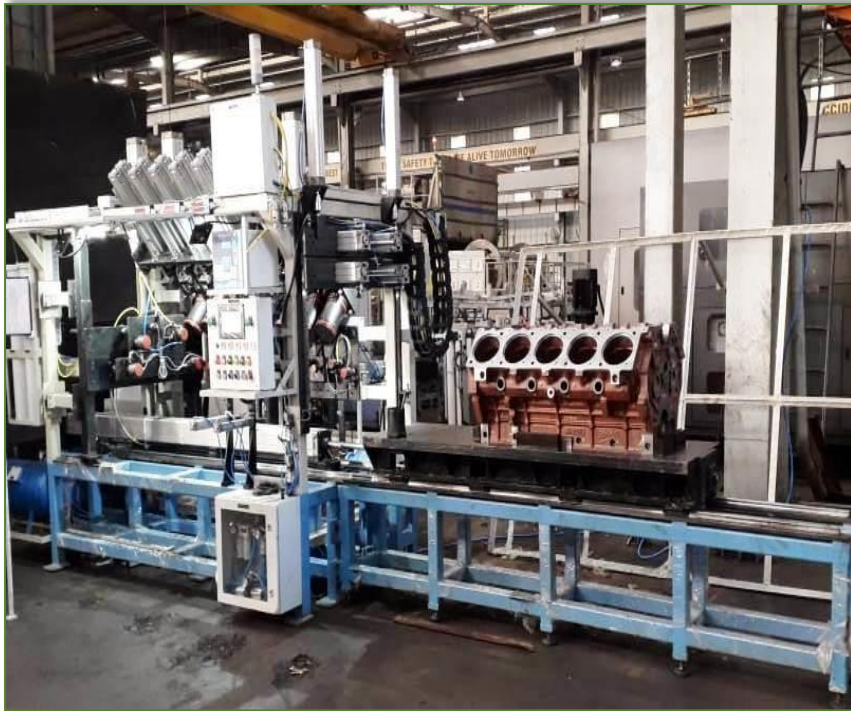
1. Our 'SHANTI' brand Differential pressure decay measurement type leak tester was used for this application.
2. Due to V banks, water passages were divided in six different cavities. So each cavity was to be tested separately. Also there was limitation at most of the places to reduce the volume of test cavity by putting dummy volume. Due to which air fill & stabilization required more time, resulting in increased in cycle time. To achieve expected results, we have set cycle time near about 50 mins. which was technically essential & so accepted by our customer.

3. To load test job easily, we have provided reciprocating pallet so that test job can be easily loaded with the help of shop floor crane on the pallet which was initially located at the outside of test station & after loading, it can move automatically towards test station by pneumatically operated cylinder. so pallet movement, clamping & sealing with pneumatic & hydro pneumatic cylinders and leak testing was carried out automatically. Upon successful completion of the leak test, test part gets stamped with acceptance mark & the tooling clamps & seals were automatically retracted. Then part was removed manually by crane after returning job pallet to load/unload station .
